Defect repair of EUV absorber layer using low acceleration voltage FIB-GAE

2006 EUVL Symposium

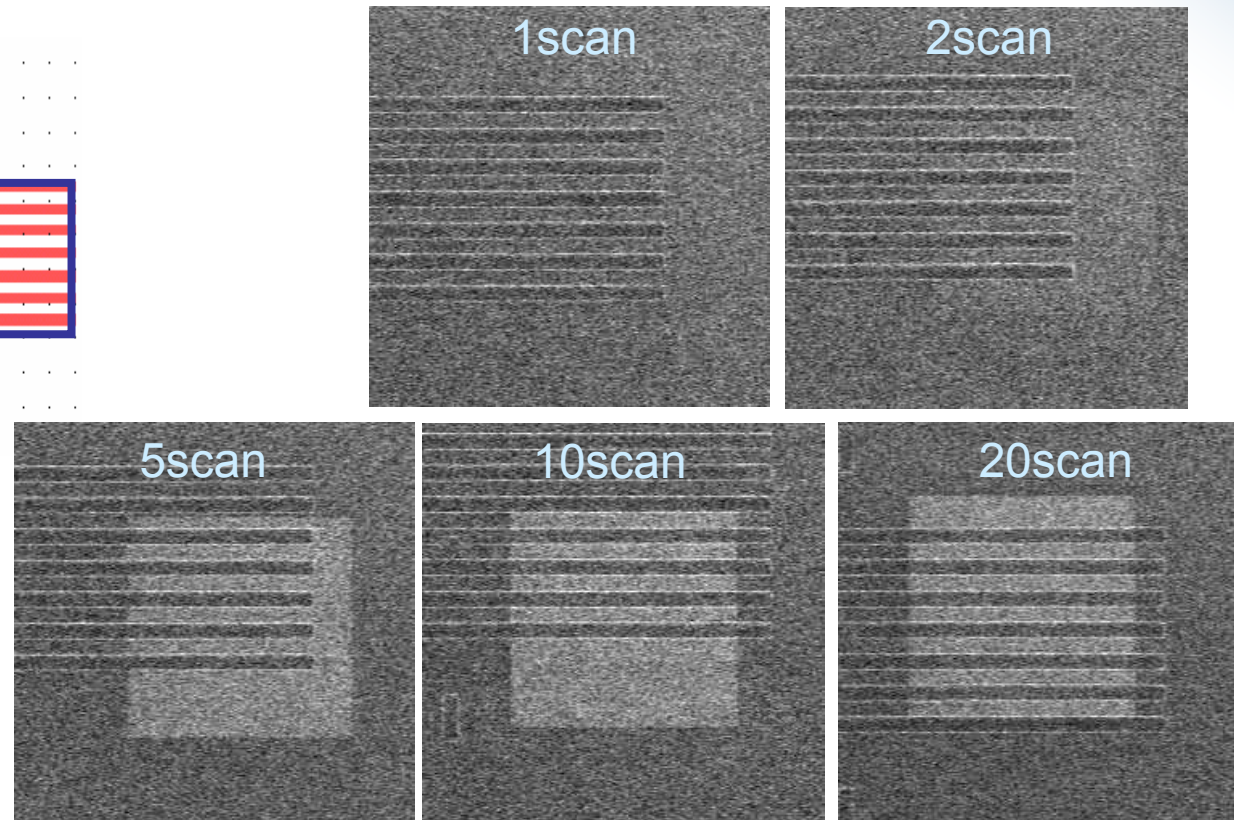
Test scan area

SEM image contrast was clearly different at FIB scan area.
Absorber damage of 20scan was about 1nm.

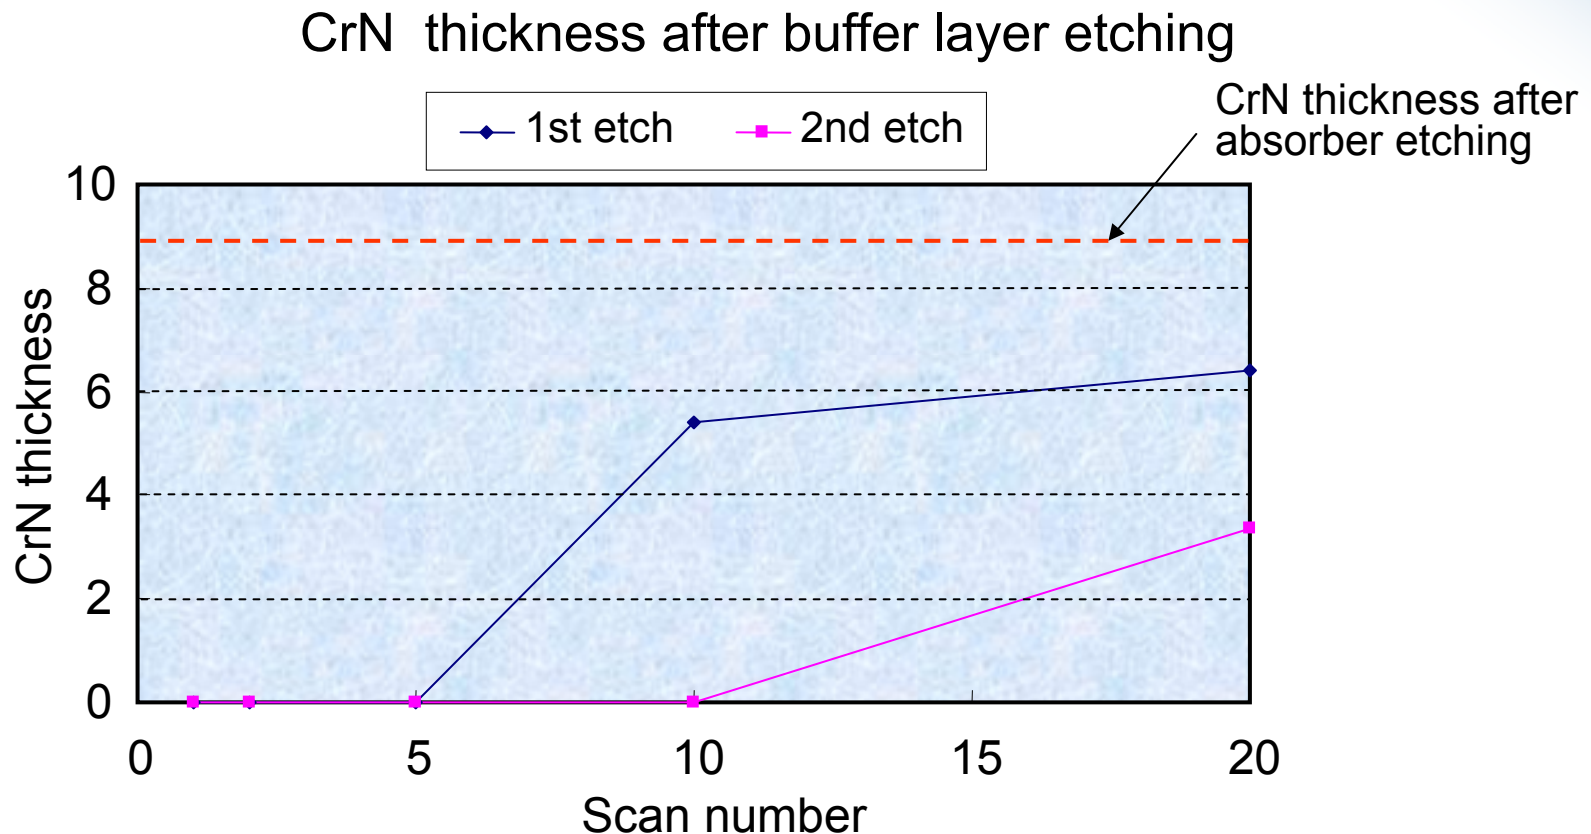
(Influence of Ga ion to buffer layer etching)

- Implanted Ga ion prevents CrN buffer layer etching.
 - CrN remains at >5 scan region after buffer layer etching.
- (Scan number should be smaller than 5 in present buffer etching condition.)

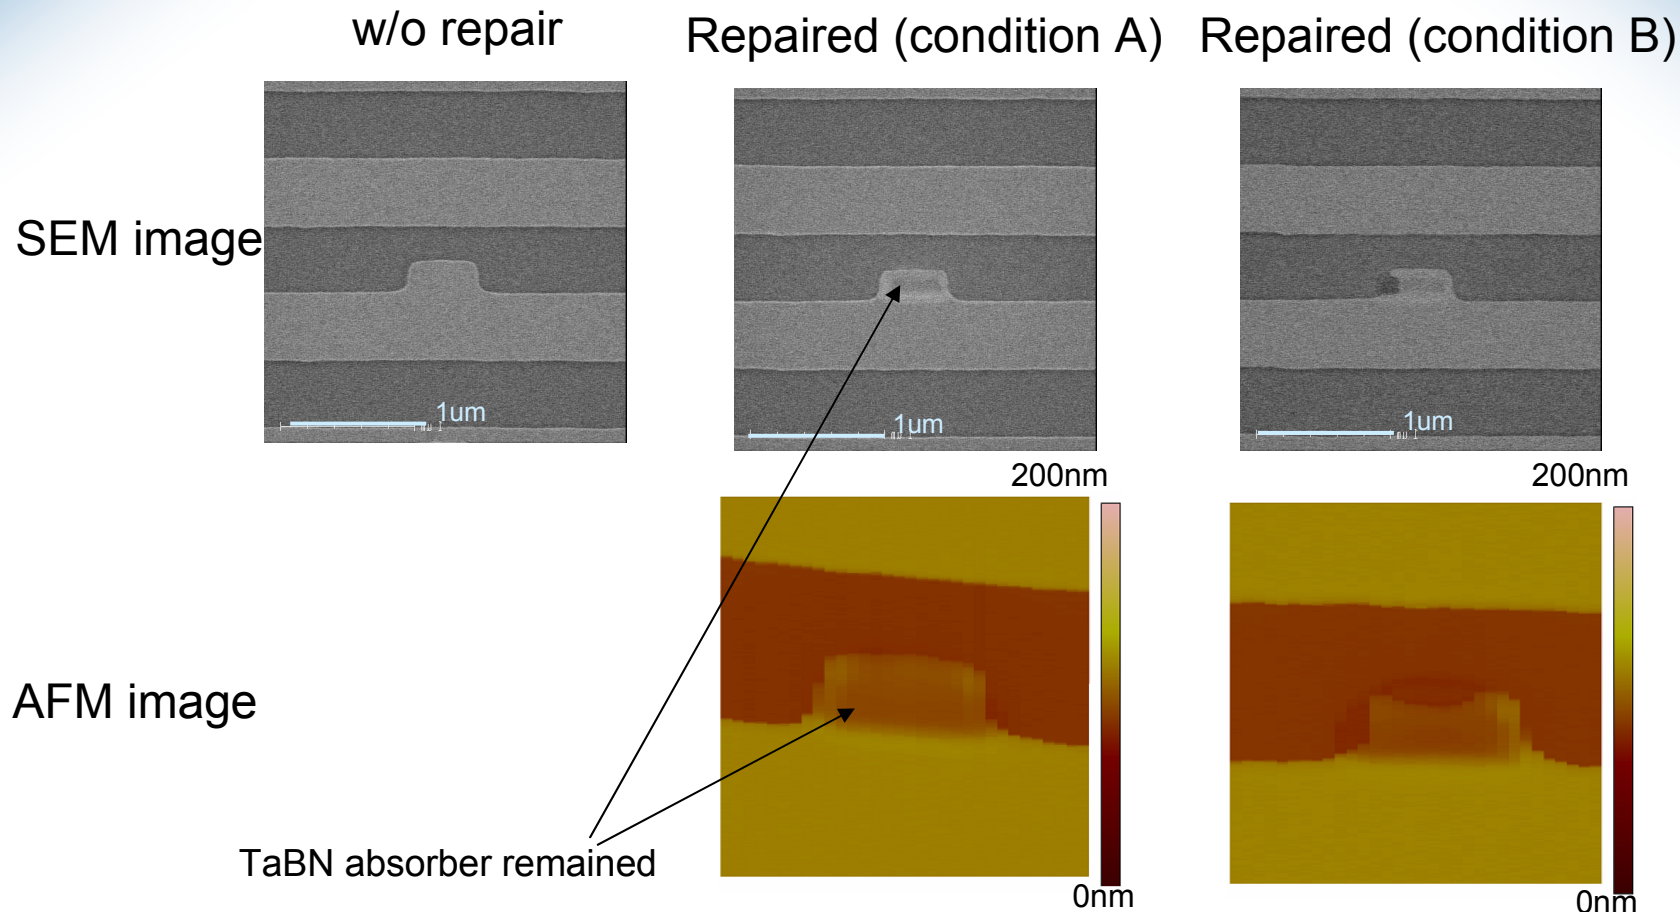
Main pattern size 100nm on wafer

- Absorber etching was short and absorber defect remained at repair region.
- 20~30nm absorber + buffer remained after buffer etch. (Remained TaBN absorber was not etched during the buffer etching)

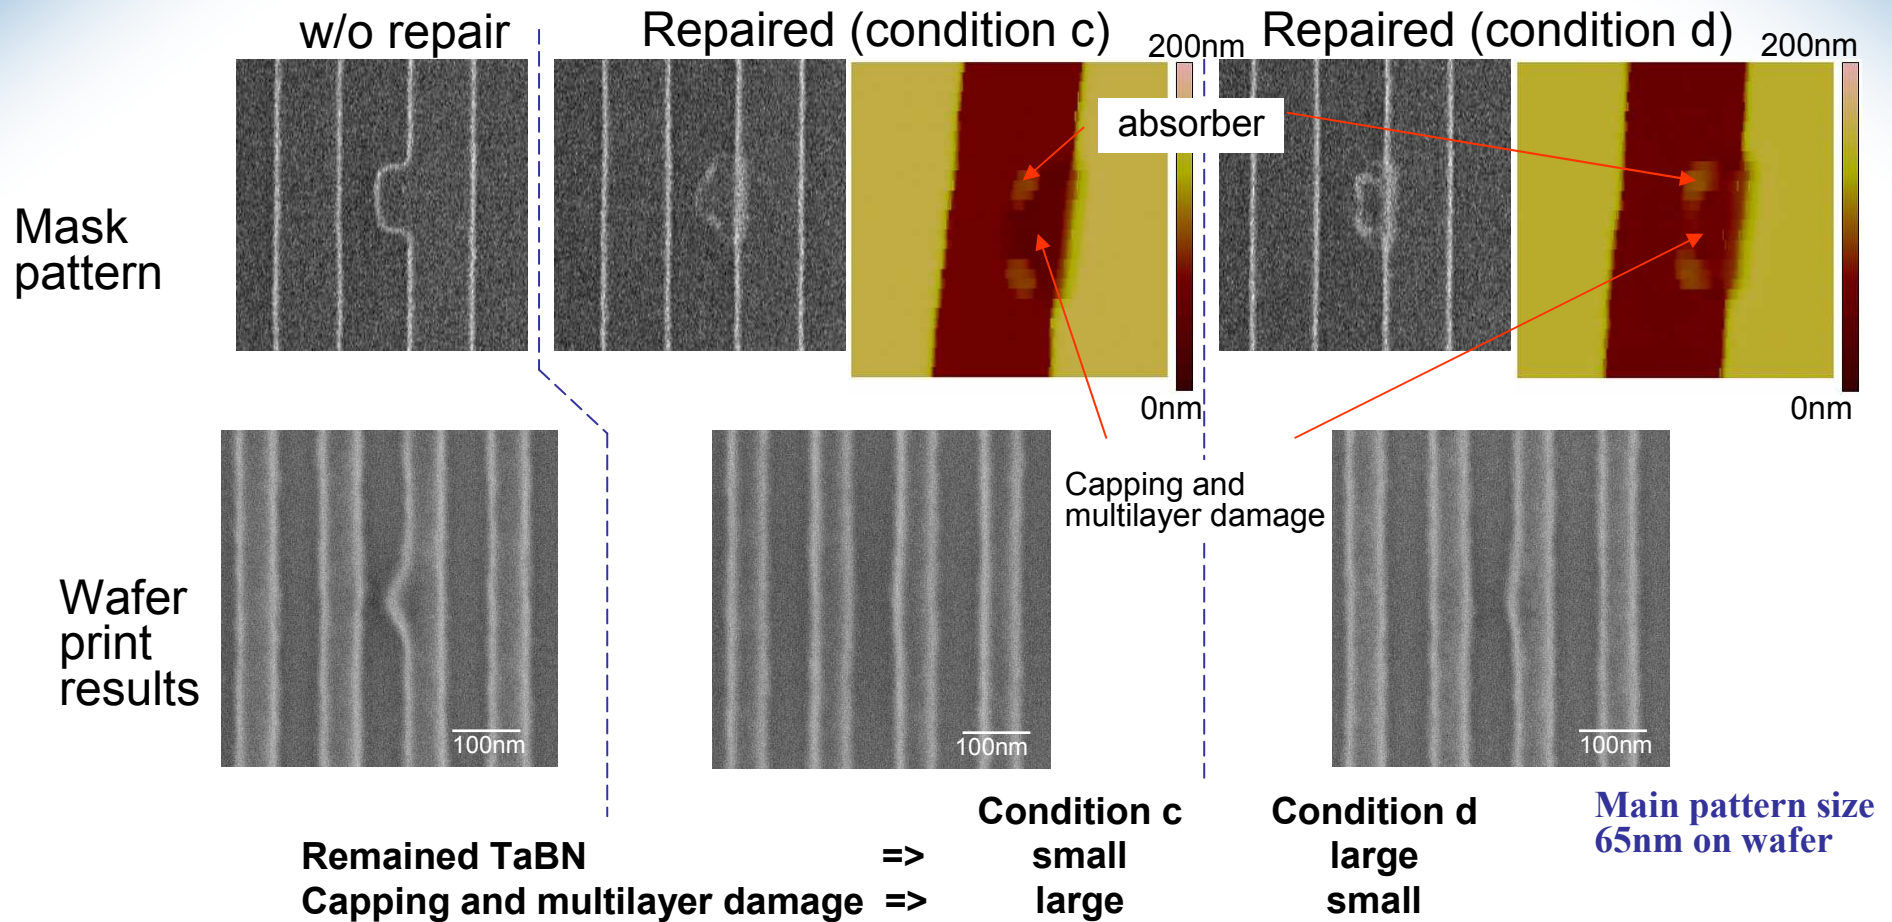
Defect repair test (2nd trial: Protrusion defect)

•Remained absorber affected to wafer print result more than multilayer damage.

FIB scan algorism was modified for TaBN etching
